# Reinstating the Low-Level Dam Spillway

Wetland Biodiversity Assessment and  
Aquatic Site Sensitivity Verification  
Report

June 2025

**REPORT:** DUVHA POWER STATION LOW LEVEL ASH WATER RETURN DAM  
SPILLWAY UPGRADING DESIGN REPORT

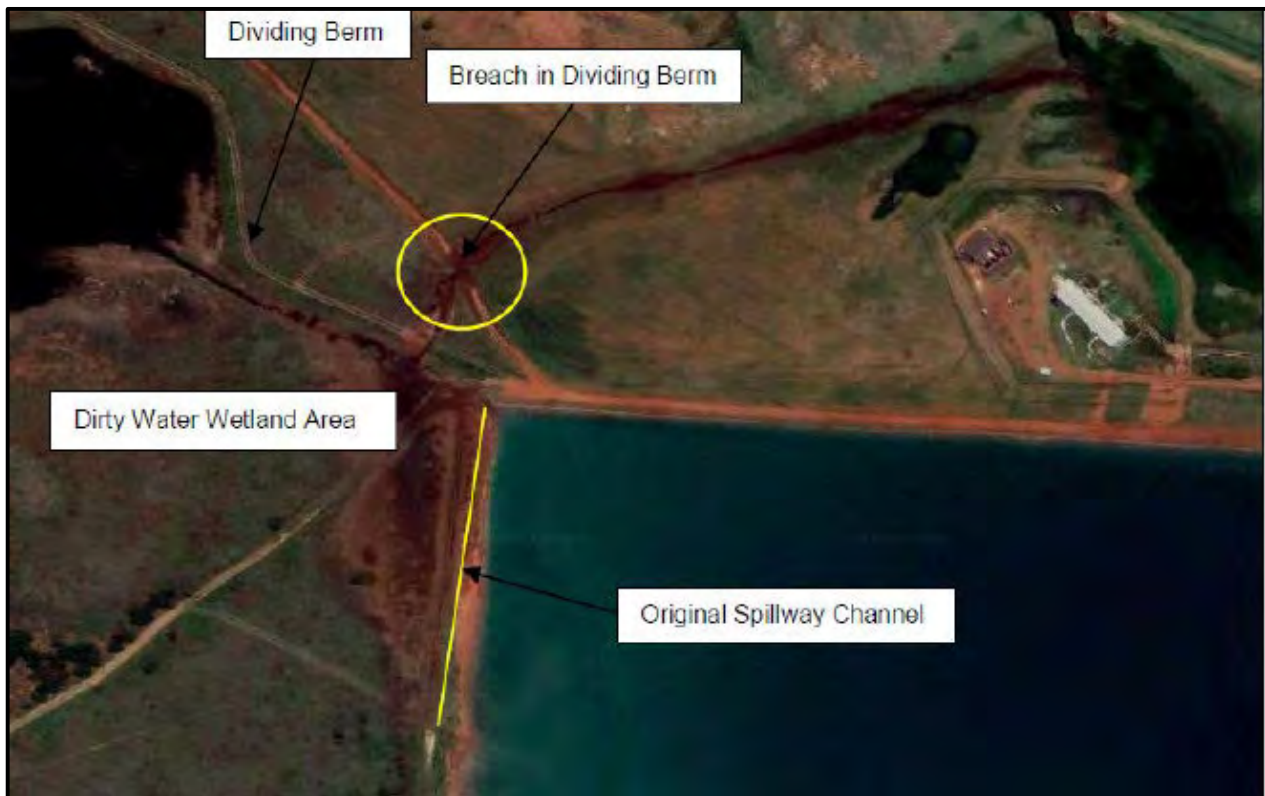
Figure 1: Water extraction proposal

- **LLD Crest Raising:** Due to observed settlement along the dam crest ( $\pm 3\%$ ), the crest will be levelled and compacted with G3–G4 gravel material to restore freeboard and prevent ponding.

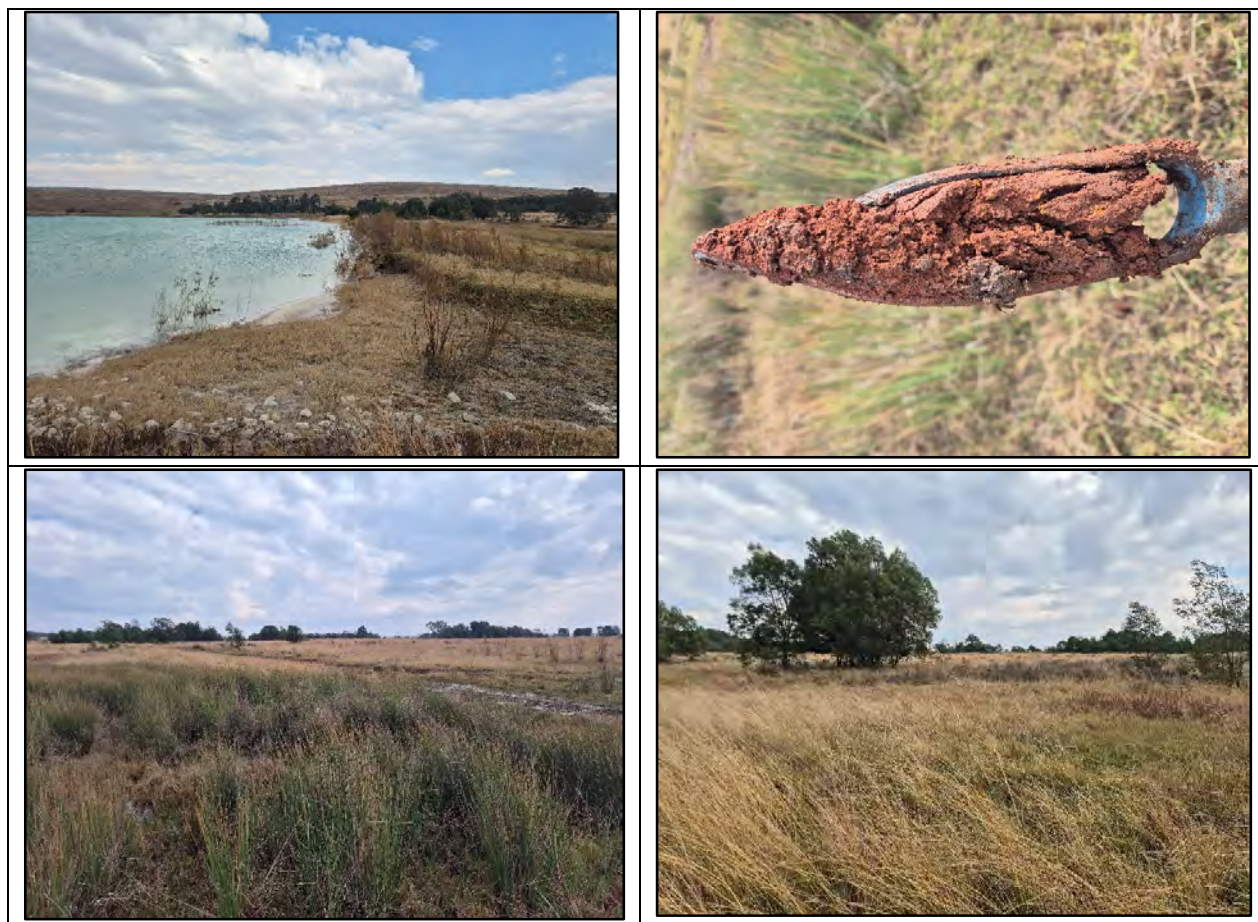
The artificial seepage wetland adjacent to the LLD spillway is characterised by soils that are persistently moist but do not display redoximorphic features, such as mottling or gleying, which are typical indicators of prolonged anaerobic conditions in natural wetlands. Instead, the soils are uniformly red (**Figure 9**), suggesting a well-drained origin not typically associated with naturally hydromorphic conditions.

Despite the soil limitations, the vegetation is distinctly hydrophytic, with species such as *Juncus rigidus* dominating the permanent (central) zone of the wetland. The edge and temporary zones support a mix of facultative and upland species, including *Cyperus longus*, *Andropogon eucomus*, *Andropogon huilensis*, *Eragrostis gummiflua*, *Haplocarpha scaposa*, *Imperata cylindrica*, *Helichrysum mundtii*, and *Sporobolus africanus*. These species indicate temporary to seasonal saturation and are consistent with wetland fringe vegetation.

Several Alien invasive species (AIS) were recorded both within and adjacent to the wetland. Invasive woody species such as *Acacia mearnsii* and *Eucalyptus* sp. were noted throughout the wetland and surrounding areas. Other AIS included *Pennisetum clandestinum* (kikuyu), *Datura ferox*, and scattered individuals in adjacent upland areas. Terrestrial edge species observed outside the wetland included *Asclepias fruticosa* and *Seriphium plumosum*, indicating a transition into more typical grassland or old-field vegetation types. **Figure 9** gives a general overview of the vegetation and substrate composition.

Figure 9: General Vegetation and substrate composition of the artificial seepage wetland?

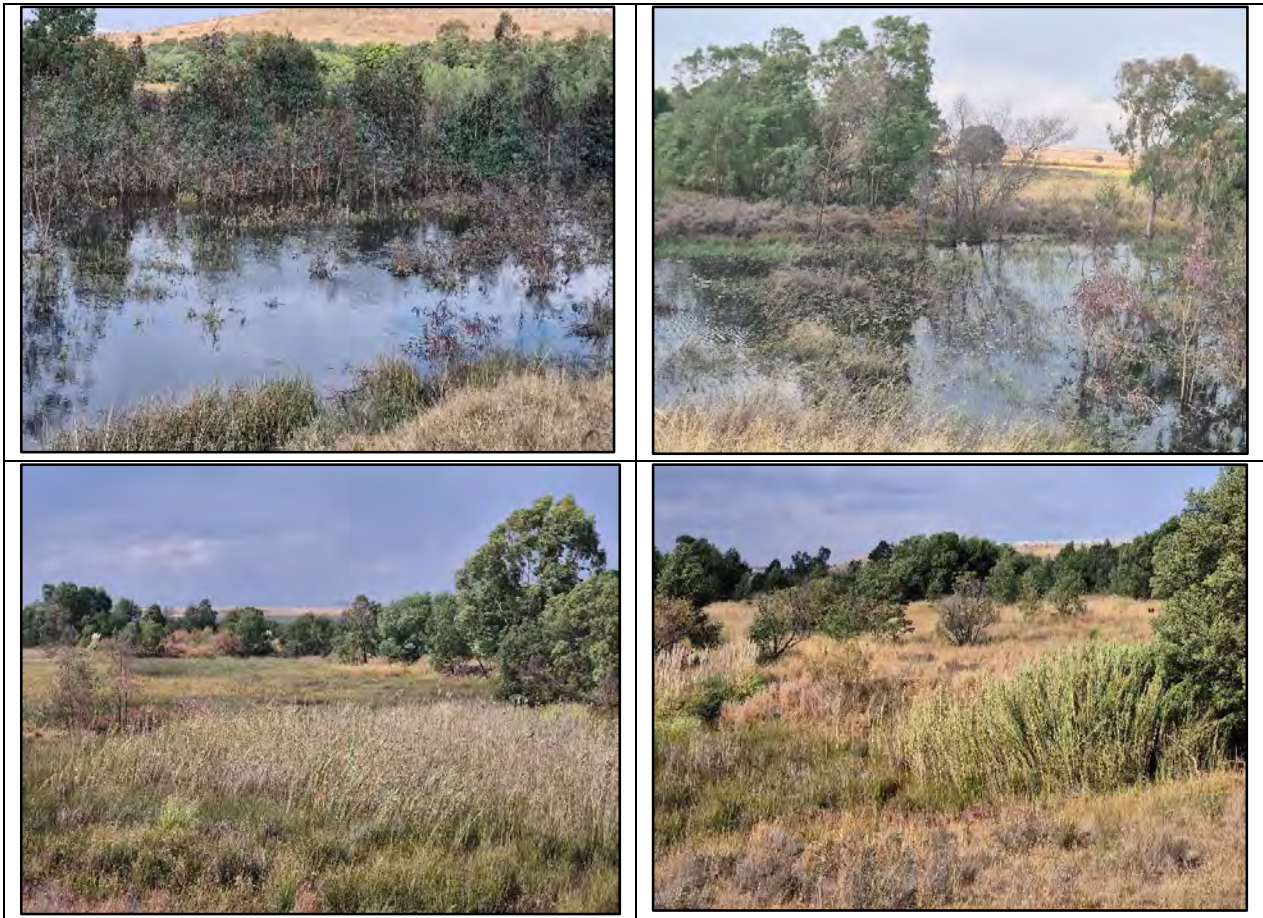
In the shallower margins, species such as *Phragmites australis* dominate, forming dense stands. The edges of the wetland include additional AIS such as *Cortaderia selloana* (pampas grass), which is known for its aggressive spread and habitat alteration. Other wetland species present in this artificial system are consistent with those found in the adjacent seepage wetland, including facultative hydrophytes that tolerate seasonal saturation.

**Figure 10: General Vegetation and substrate composition of the artificial wetland -Previously Disturbed**

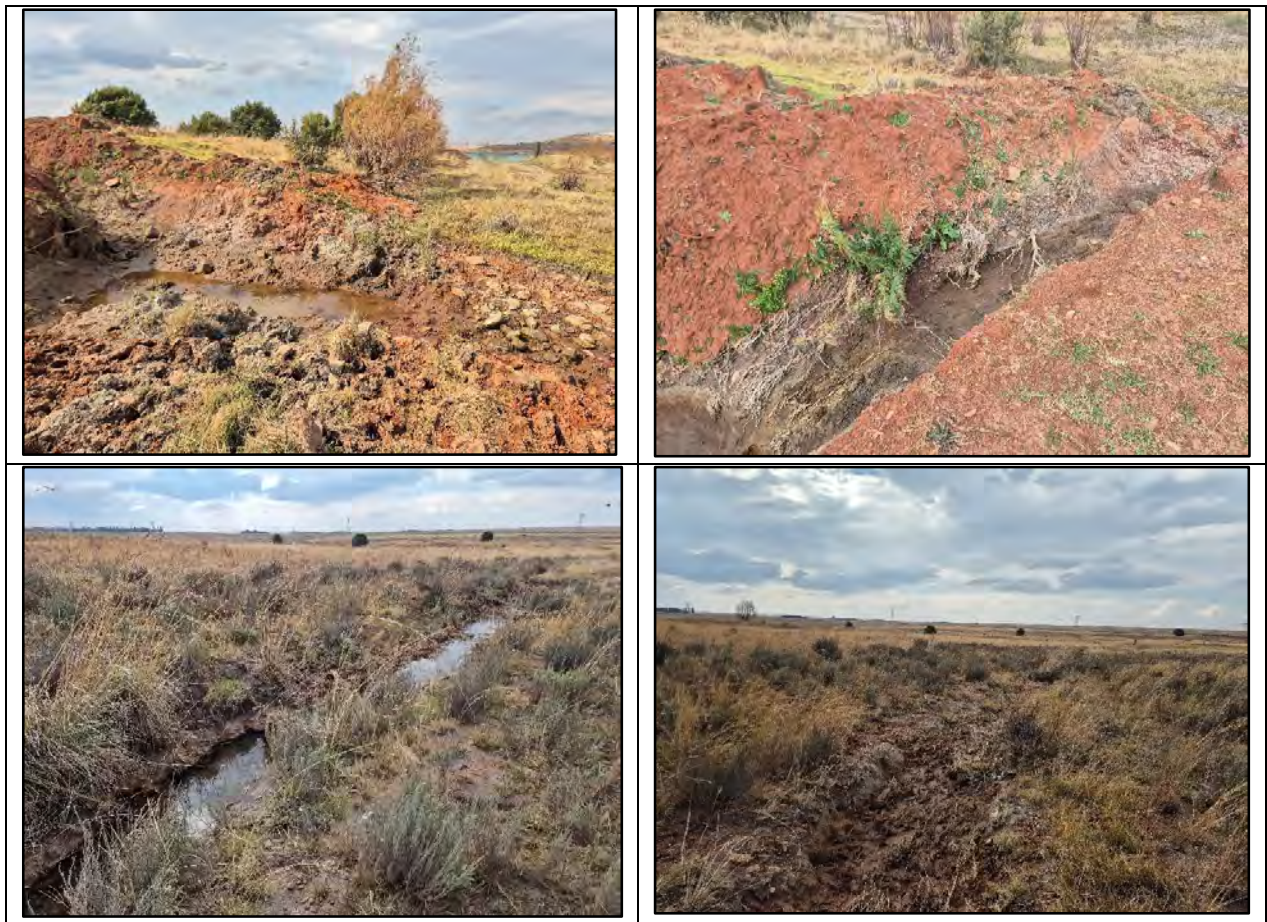
The artificial canal and dividing berm, including the breached area, exhibit clear signs of anthropogenic origin. The canal is straight and engineered, with banks dominated by terrestrial vegetation, including grasses and scattered alien invasive species (AIS). Standing water was observed in both the canal and breached section during the site visit, likely the result of recent rainfall or a spill event. Hydrophytic vegetation was limited within the canal channel itself, with only sparse wetland species present until the point where the canal discharges into the natural unchannelled valley-bottom wetland. At this interface, the vegetation shifts noticeably, with indigenous wetland species such as *Typha capensis* becoming dominant.

The dividing berm was vegetated primarily by grasses and invasive species, similar in composition to the adjacent seepage wetland, and showed signs of trampling by livestock or wildlife, particularly in areas where water had pooled. The soil within the canal channel was dark red and clay-rich, consistent with the soils observed in the artificial seepage wetland, and lacked redoximorphic indicators typically associated with prolonged natural saturation.

These features further support the classification of the canal and berm as artificial and disturbed, functioning primarily as flow diversion structures rather than natural wetland systems. Their ecological integrity is low, although connectivity to the downstream natural wetland warrants attention for broader management purposes.

**Figure 11: General Vegetation and substrate composition of the artificial canal and Dividing beam – including breached area**

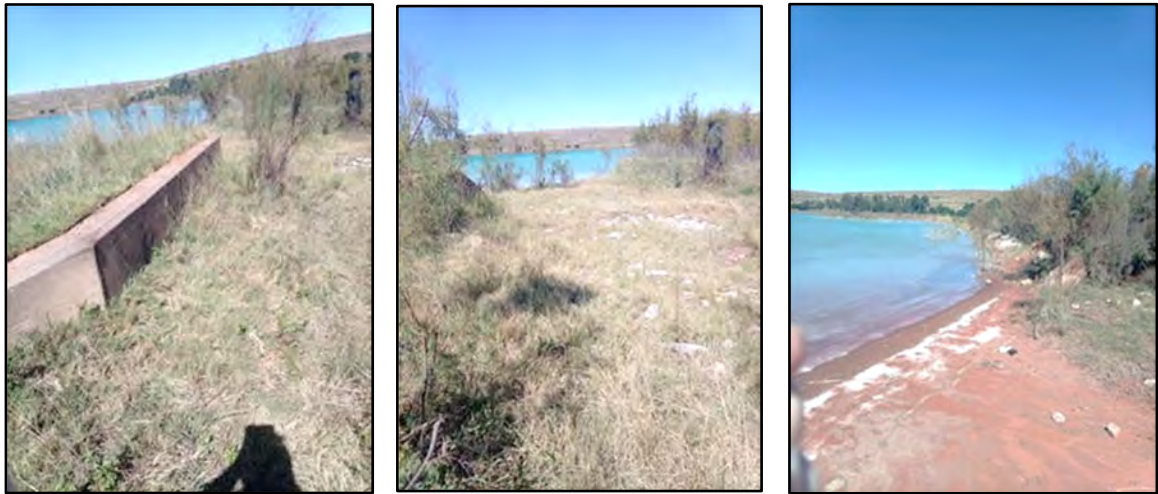
Figure 22. Detail of existing Spillway construction site looking west, southwest and south. Existing structure and retaining wall. (Photos S.M. Miller.)

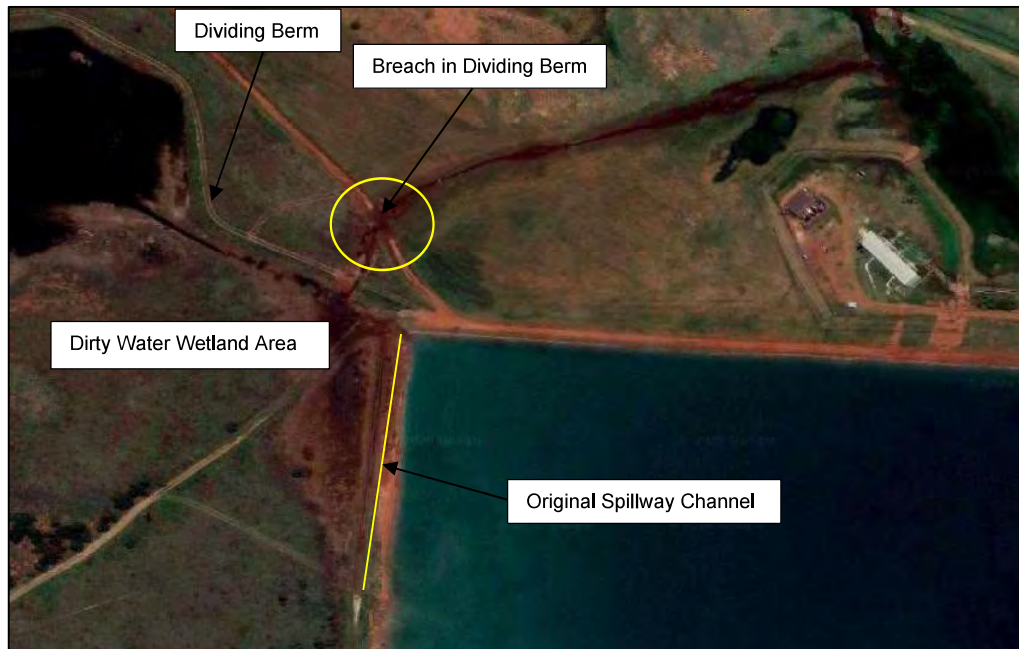
Figure 10: Google Image showing dam's spillway section and dividing berm

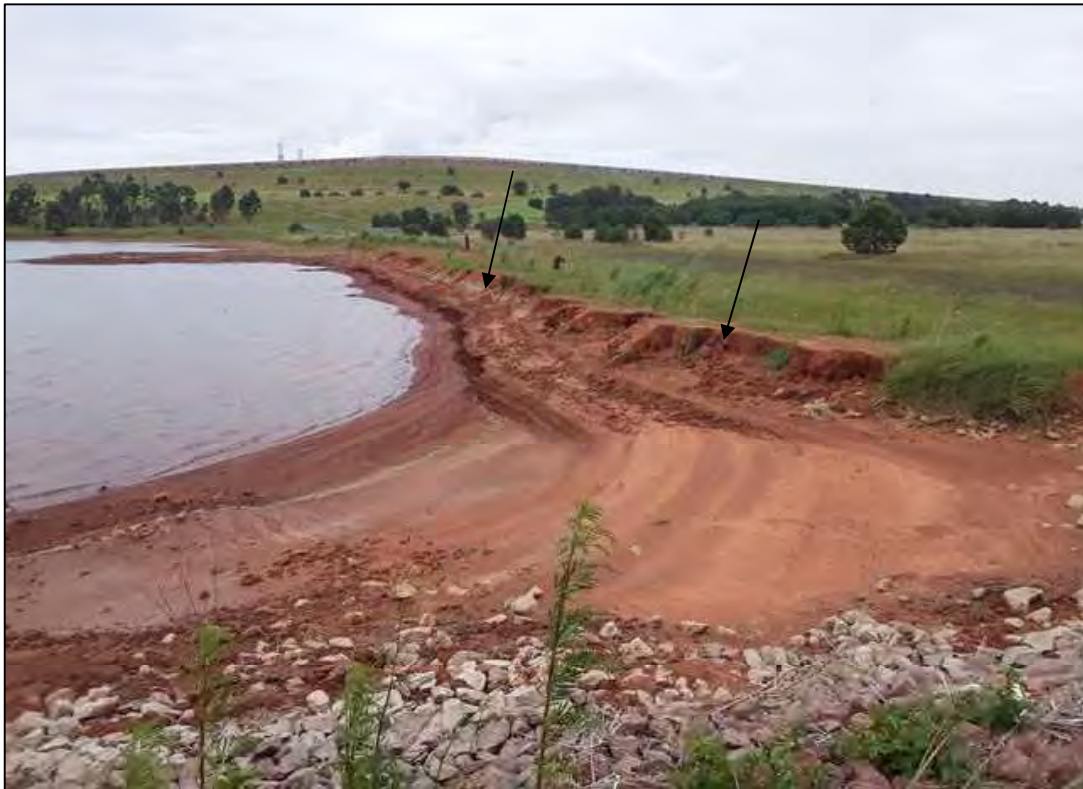
**Figure 11: Image of earth berm placed within the original spillway channel**

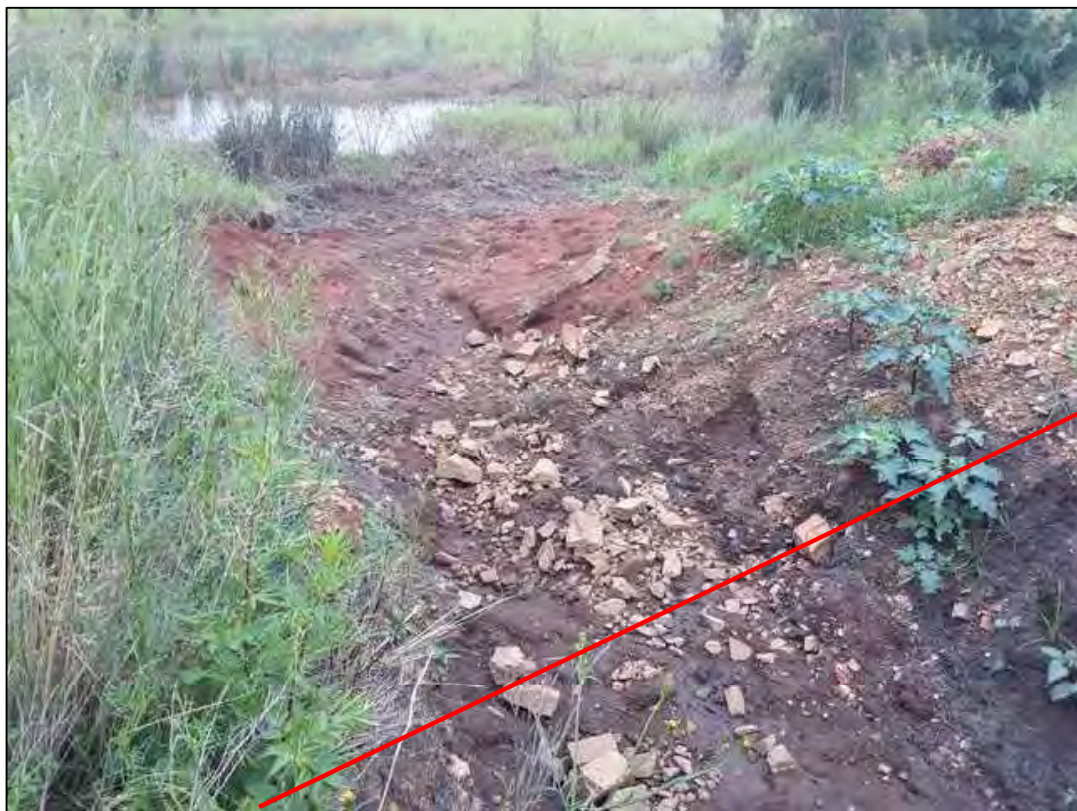
**Figure 12: Image of manmade breached section at dividing berm which was necessitates because of high water levels in the LLAWRD (proposed weir position indicated with red line)**
